# Manhole Inspection Summary

Manhole # S35EE\_034MH

Insp Date: **3/5/07 1:03 PM**

**Location** Address: **106 PRESTON ST**

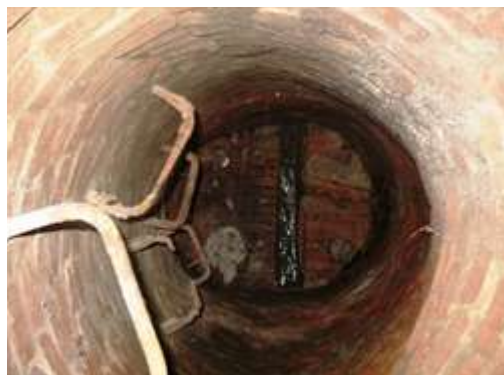
Top View

Corroded and missing steps. Evidence of surcharge - Bench debris.

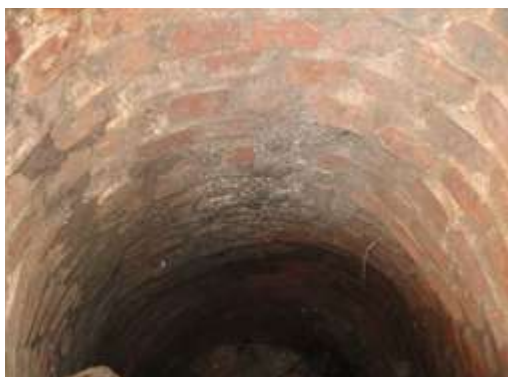
Defect

Adjustment deterioration and infiltration. Corbel and Barrel infiltration - other side.

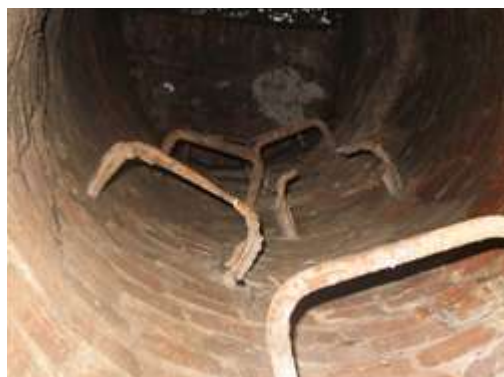
Defect

Corroded and missing steps.

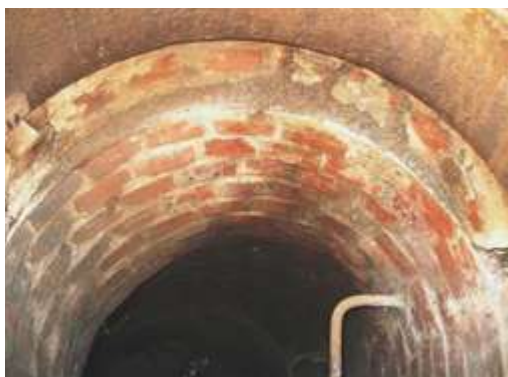
Defect

Frame leaks. Frame offset. Adjustment deterioration and infiltration. Corbel and Barrel infiltration.

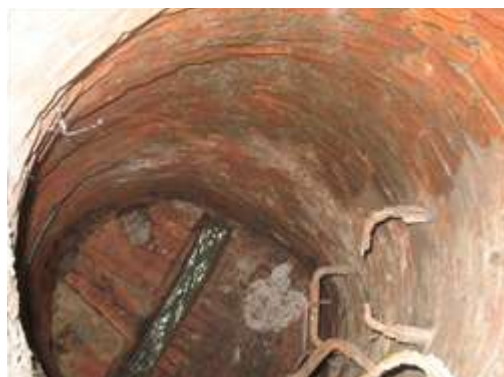
Defect

Corbel and Barrel infiltration.

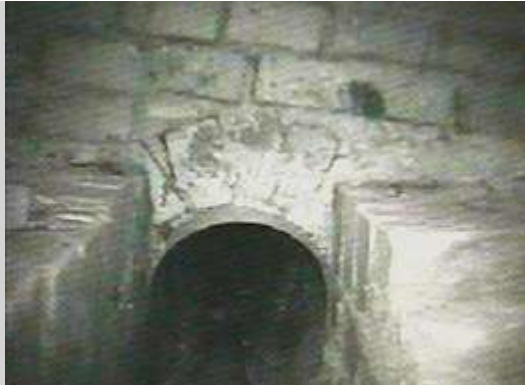
### 8 in. Circular Gravity Sewer Pipe Out @ 12 O'Clock

Infiltration: **Evidence** Pipe Seal Cond: **Unknown**

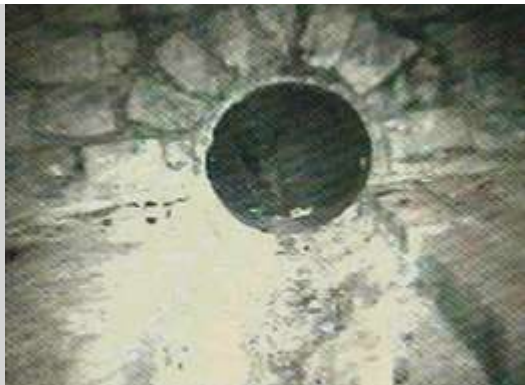
### 8 in. Circular Gravity Sewer Pipe In @ 3 O'Clock

Infiltration: **Evidence** Pipe Seal Cond: **Unknown**
